SERVICE TECHNICAL INFORMATION

ONE POINT REPAIR

UTSUNOMIYA, APRIL 30, 1996
REF. NO. : SI-96-006
CUSTOMER RELATIONS & SERVICE DIV.

MODEL : AM - F3
SUBJECT : Improving servo operations when recording
SYMPTOM : Because servo operations during recording are sometimes unstable, when playing the disc after recording, there are cases in which the recording was made in a dropout condition.
REMEDY : In order to improve servo operations, replace the 5 parts listed below.
(Refer to the figure on the next page for the arrangement of parts on the board.)

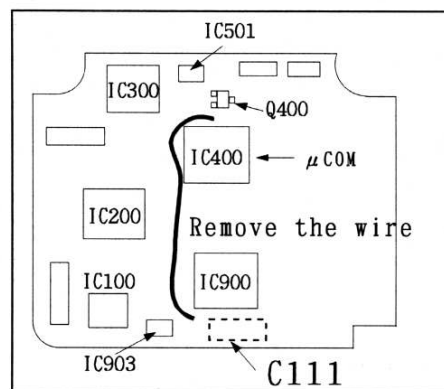
Parts position

MODEL : AM-F3
SUBJECT : Occasional dropout (microcomputer upgrade)
CONTENTS : Occasional dropout occurs (during play / record). Perform the following remedy for the relevant sets. Confirmation is very difficult because the symptom occurs in aluminum discs that can only play and in MO discs that play and record. For this reason, always perform this remedy when the customer indicates such a problem, even if the symptom does not occur.

- ① The previous microcomputer and the new type have upper compatibility. However, their circuit configurations are different and so the circuit modification shown below must be performed.

REMEDY : Replace Ref: IC400 with the new microcomputer (CXP81840-503). (Presently, 3 types of microcomputers are installed.)

1. Remove one wire from the sets with CXP-81840-115.
(See figure on the right.)
 2. Replace C111 0.1μF with resistor 1KΩ
(C111 is on the bottom side of the board. Check with S/M for the positioning of the parts.)
[Part No.: Resistor 1KΩ 88-108-102-080]

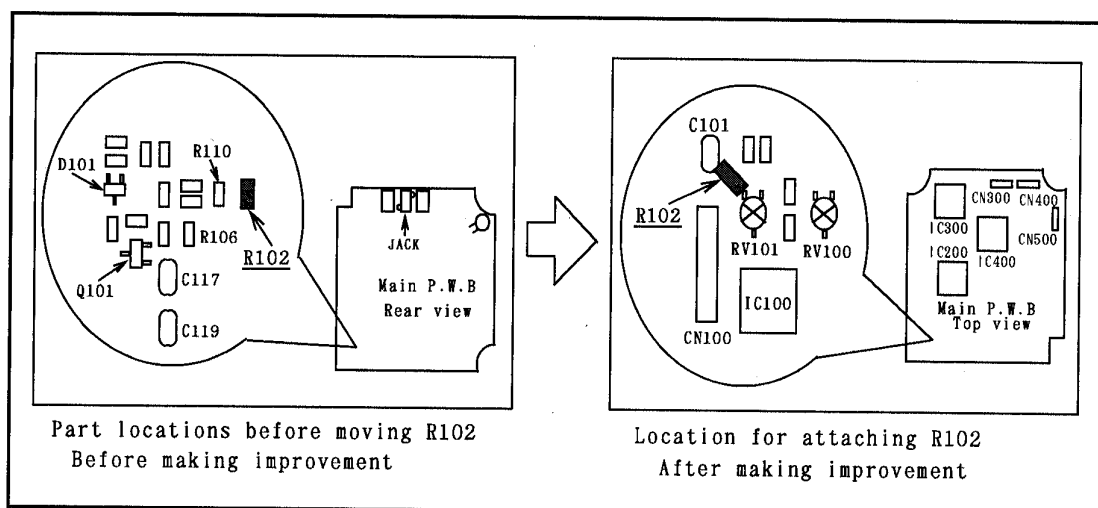
MODELS: AM-F3
SUBJECT: PICK UP flexible cable disconnection
CONTENTS: For the above model, there are cases in which operations become faulty due to a disconnection of the PICK UP flexible cable. When repairing units with this symptom, the unit may again need to be repaired after a short time if only the PICK UP is replaced. For this reason, the following procedure should also be performed whenever the PICK UP is replaced.

The PICK UP flexible cable is located between the PICK UP main body (mechanism section) and the main board. When a shock or vibration is applied to the set, the mechanism will momentarily lower causing the PICK UP and board to press against the flexible cable.
(Because the mechanism is supported by a rubber damper, it only presses against the flexible cable momentarily.)
It is likely that the cornered section of R102 (chip resistor) on the board causes damage to the flexible cable.

METHOD: Change the position of R102. Change the flexible cable so that stress will not be applied even when pressing against the cable. Remove R102 from the rear side of the board (prescribed position), and connect (line) between the C101(+) terminal and RV101 on the front side of the board. (See the figure below.)

Note: After moving R102, there may be some sections of solder remaining at the location from which the resistor was removed. If this solder remains, it is likely to cause similar faulty operations. Always confirm that all of the solder has been removed after removing the resistor.
